Harrelson Hall

Renovation and Replacement Study

DRAFT
September 26th, 2003

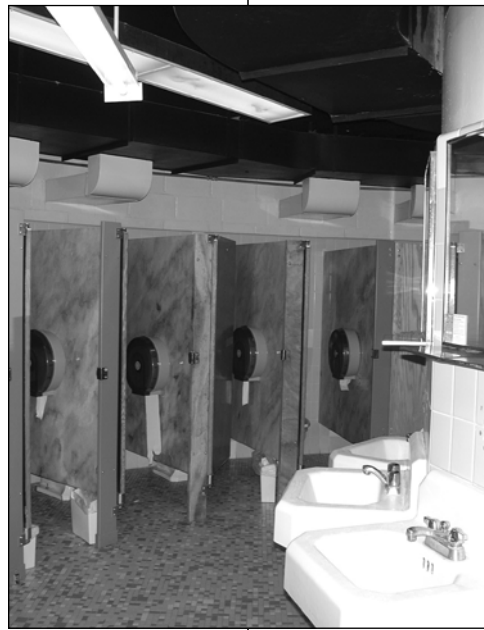
Accessibility

Women's toilets must be added to each floor in the building to meet ADA and NCSBC Vol. 1-C accessibility codes.

Women's toilets must be added to each floor in the building to meet ADA and NCSBC Vol. 1-C accessibility codes. The existing men's toilets at the central core can be modified to meet these codes but, because the curved, sloped ramps cannot be modified to provide a compliant accessible route to the toilets, new accessible women's and men's toilets must be added in the outer perimeter ring of the building. This will result in a reduction of office space.
